# Corbett School Seismic Review

## Corbett School District

February 6, 2013

Re: Corbett School Seismic Review  
Corbett School District  
Corbett, Oregon

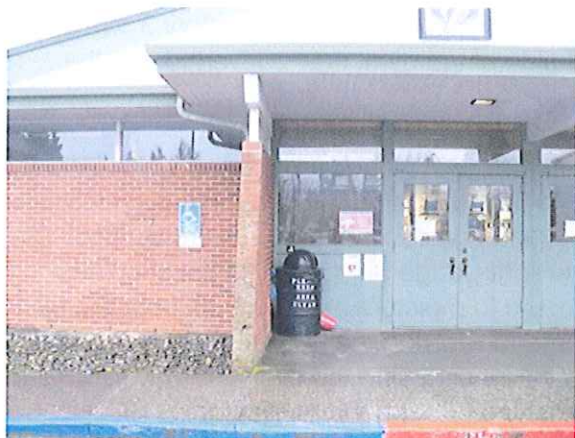
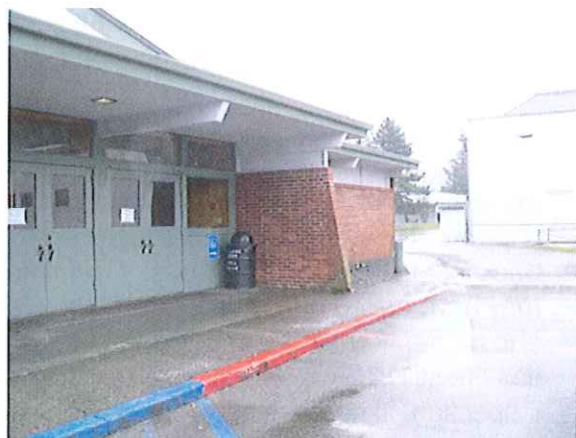
At the north side of the building there are two brick wing walls, one each side of the entry. These walls are constructed with double wythe un-reinforced brick. The walls are supported on a foundation stem wall, however, the top of the walls stop approximately two feet from bottom of the roof beams. Since the wall tops lack lateral support, they have tilted and appear to be out of plumb. The cantilevered glue-lam beams above the walls also appear to have rotated. This location is the entry and exit for the building and there is concern regarding safety during a seismic event. We recommend removing and replacing the walls and extending to the roof so the walls are made laterally stable. Or as an alternate, provide new columns at each side of the wall ends and fasten it to the foundation and the roof structure above to support the walls to keep them from falling.

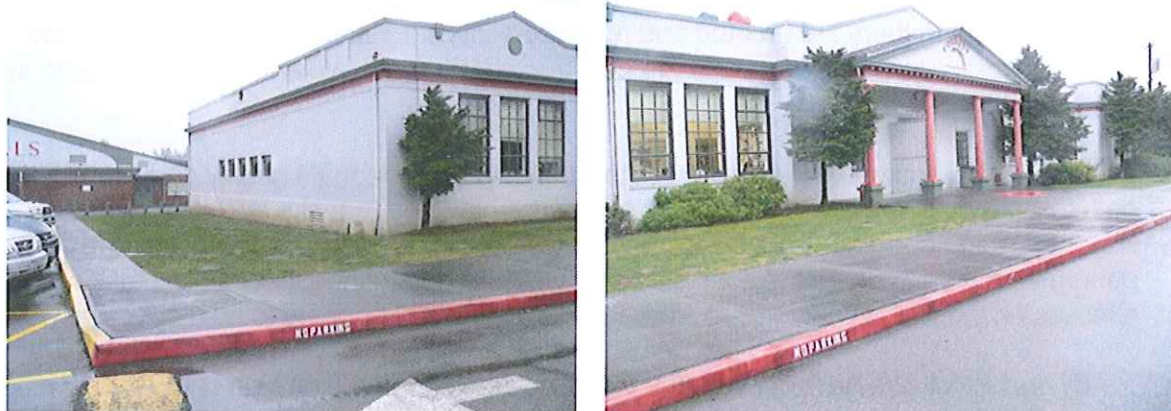
Exterior walls are constructed with un-reinforced clay tile combined with brick veneer on the outside face. The interior bearing walls of the old Gymnasium appear to be constructed with same type of clay tile. The cellular clay tiles are approximately 8 or 12 inch wide, 12" long and 6" tall with the cells running horizontally so the wall could not be grouted. At the gymnasium, walls appear to be approximately 19' tall. It is not clear if there are any anchors at the top of walls to tie the walls to the roof framing above, so the walls may be laterally unsupported. The north wall of the building includes several oversized windows that are over 8 feet tall with approximately 12" piers between the windows. The piers appear to be overstressed for gravity as well as lateral loads.

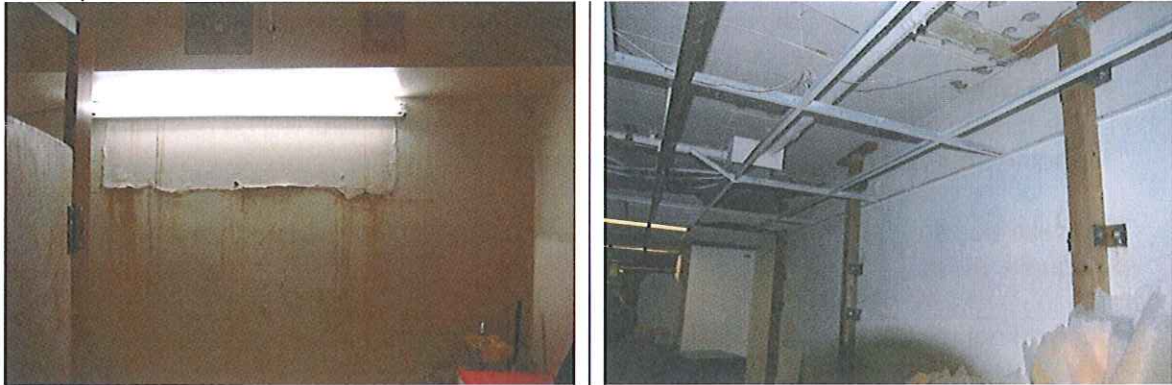
The east, west, and the south side basement walls originally had windows which have been in-filled with concrete blocks. Stress concentration on the concrete piers between the windows has caused some horizontal cracks which have resulted in moisture intrusion from exterior. It appears that in an earlier time as an effort to repair this issue, 4x4 wood braces have been installed on the inside face of the wall with mechanical anchors. The 4x4 wood posts do not have adequate strength to support the wall in the event of an earthquake.

In the event of an anticipated earthquake, this building does not have adequate strength and load paths to resist forces. The masonry walls may fail and there is a chance that the building will collapse.

1. Roof framing may need additional reinforcing. Extent of this work will be determined when structure is exposed for review and evaluations.
2. New ½" plywood roof diaphragm is required. Existing roofing should be removed so plywood can be installed directly to existing roof structure.

3. New ½" plywood may be required on some of the attic floors on top of ceiling joists to create diaphragms for lateral support of walls.
4. New blocking and connections to new lateral support system will be required for every diaphragm

5. Provide new posts at each end of the existing roof trusses in the Gym section
6. To improve the masonry wall support, new 3x8 studs or light gage metal studs at 16" on center will be required on the inside of walls. These framing members will be anchored to the existing masonry walls with a special type of epoxy anchors with screens. The anchors should be so spaced that not more than two square feet area of

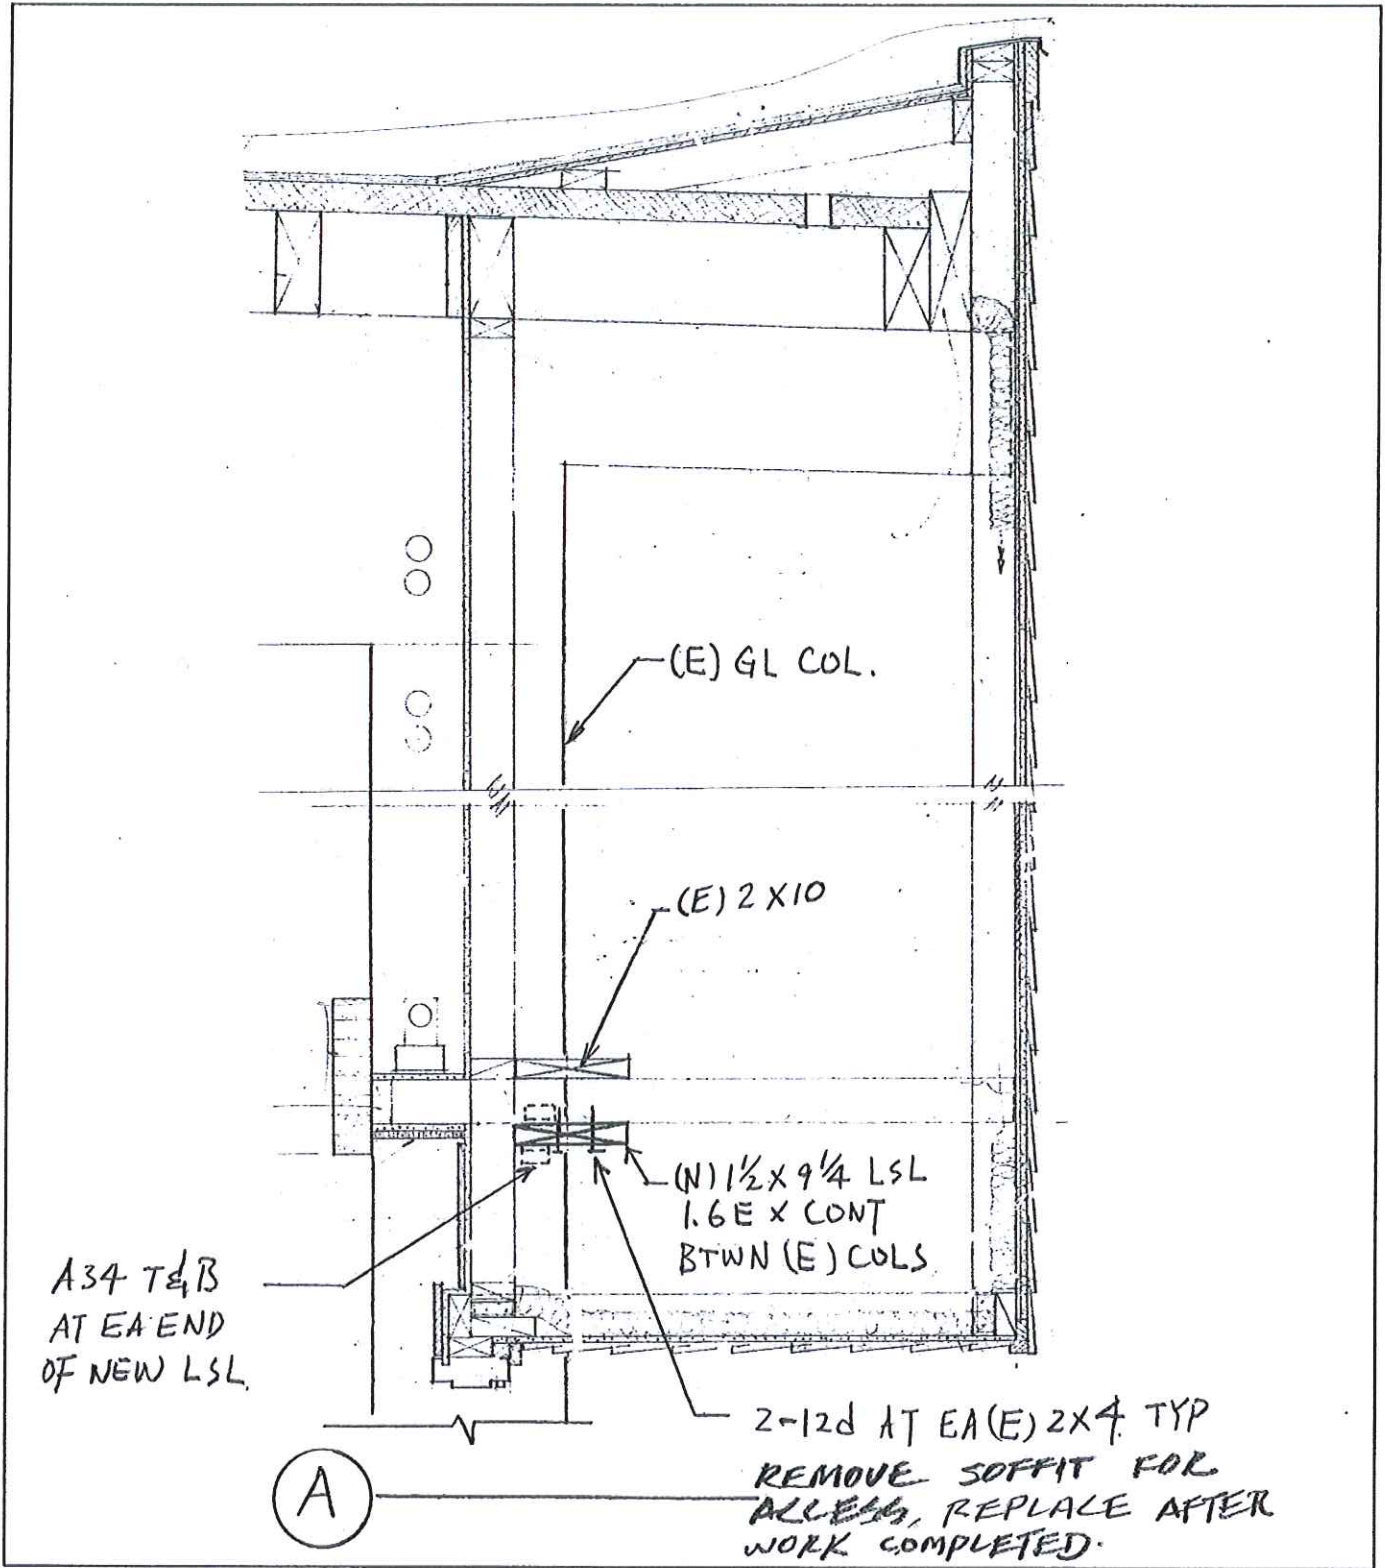
<p><b>Associated Consultants, Inc.</b> Structural Engineers</p> <p>100 East 13th Street • Suite 10 • Vancouver, Washington 98660 Portland: (503) 384-0460 • Vancouver: (360) 699-0607</p>	Project	Corbett School	Job No.	13-109
	Location	Corbett, Oregon.	Date	01-18-13
	Client	Rommel	Sheet No.	11

Framing around the windows consists of glue-lam columns which supports the roof beams. At mid-height there are glue-lam beams which are hung from the inside edges of the columns. These beams provide lateral support for the wall above the windows as well as creating a niche for lighting fixtures. The beams are inadequate for wind support and reinforcing is required. For repair we believe the exterior soffit above the doors and windows may be removed to install a new 2x10 (Select Structural DF) or 2x10 Timber Strand LSL at the bottom of the existing 2x4 framing per attached detail 'A' .

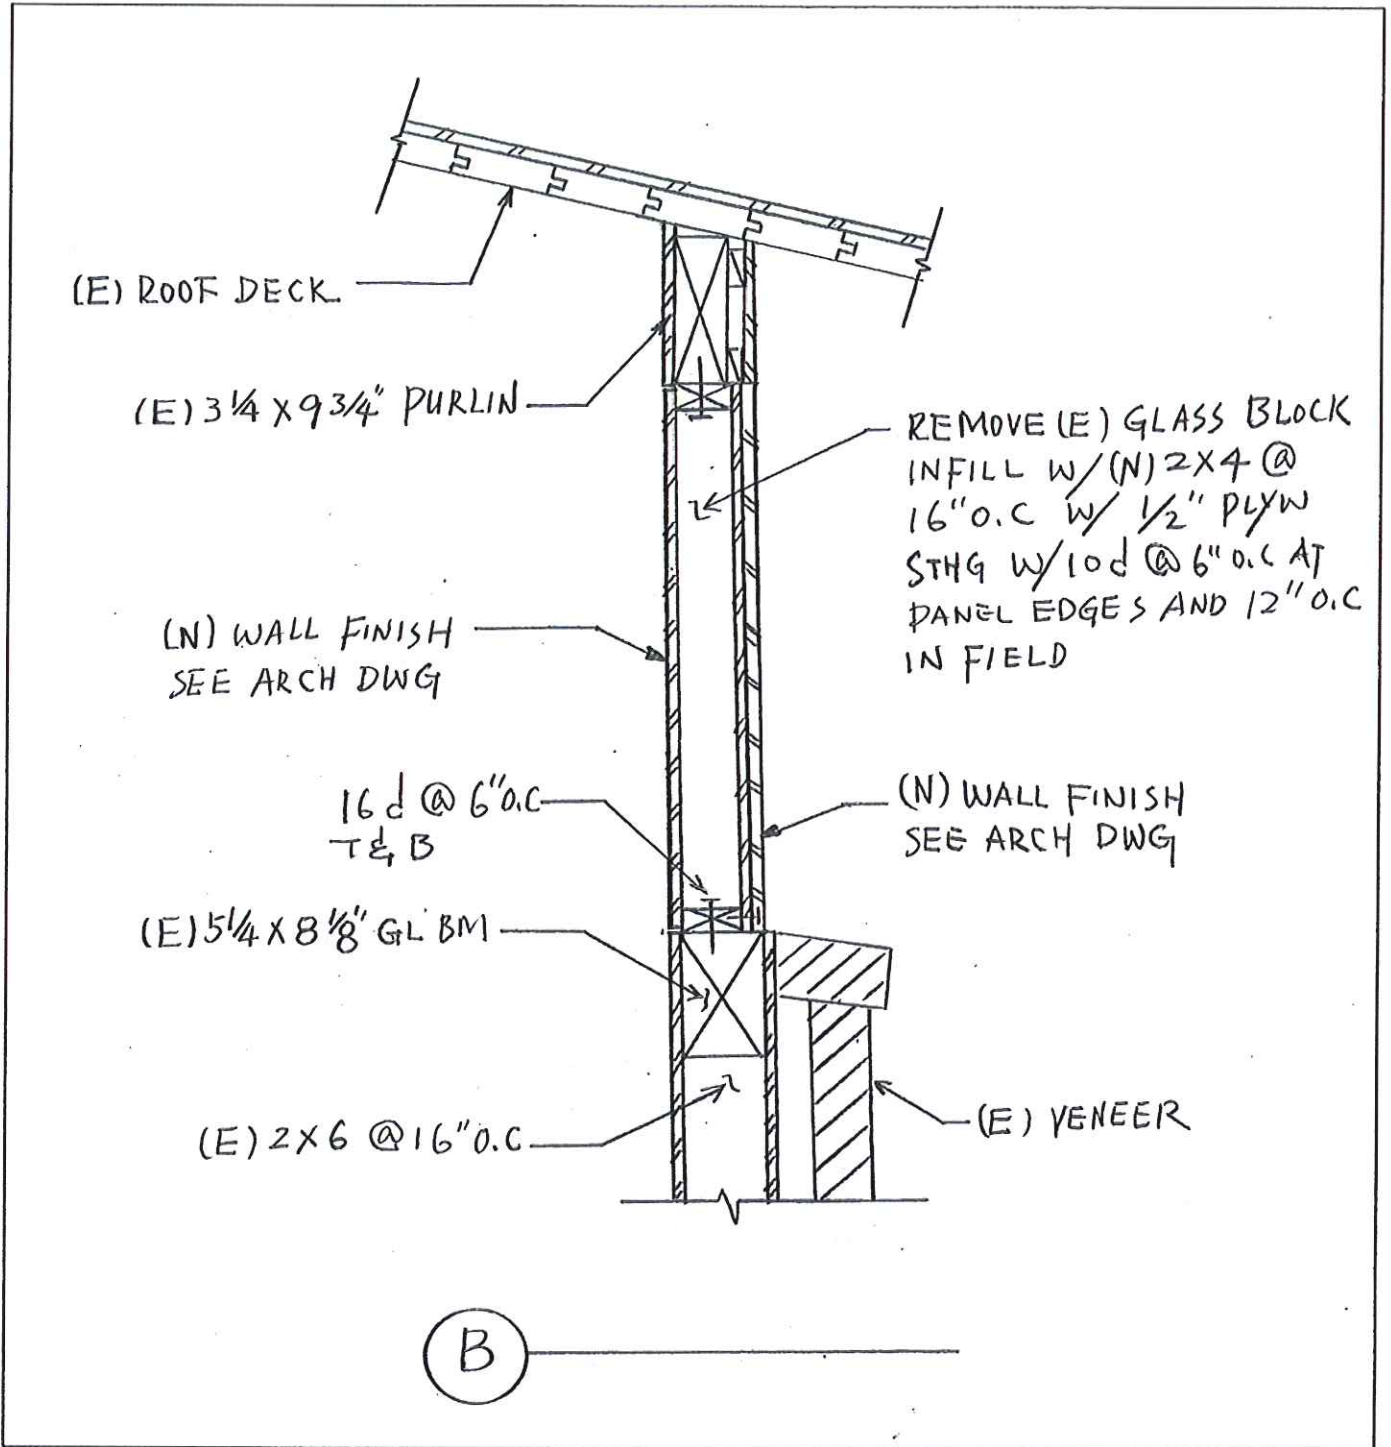
<p><b>Associated Consultants, Inc.</b> Structural Engineers</p> <p>100 East 13th Street • Suite 10 • Vancouver, Washington 98660 Portland: (503) 384-0460 • Vancouver: (360) 699-0607</p>	Project	Corbett School	Job No.	13-109
	Location	Corbett, Oregon.	Date	01-18-13
	Client	Rommel	Sheet No.	12

Our review of the drawings determined that the building is structurally satisfactory for gravity loads. At the east and west sides there are sections of glass blocks at top of walls which cause discontinuity between the roof diaphragm and the shear walls below the glass block panels. We recommend removing at least two bays of glass block at each wall and infilling with studs and plywood per attached detail 'B'

Vertical load supporting elements appear to be structurally satisfactory. The walls have adequate strength to support earthquake and wind loads, however the shear path from the existing roof diaphragm to the shear-wall at the west side of the corridor is lacking. We recommend installing new 1/2" plywood, per attached detail 'B', on the face of the pony wall, from the ceiling framing to the underside of the roof above that wall.
